World Trade Center Building Performance Study:

*Data Collection, Preliminary
Observations, and
Recommendations*

FEMA 403 / May 2002

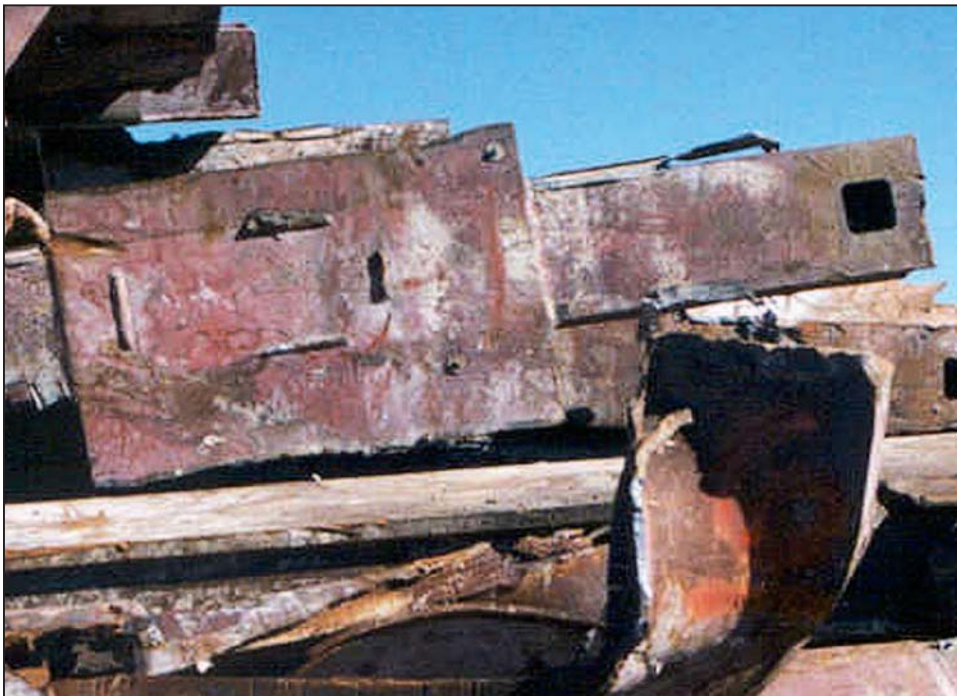
Many of the bearing seat brackets and the damper angle connections on the column/spandrel beam plate were completely sheared off. Only the weld segments remained on face of the column/spandrel beam plate (Figure B-11). This mode of failure appears to be due to excessive vertical overloads on the floor system. This is in contrast with the failure mode exhibited in Figure B-9 where the bearing seat bracket has pulled away from the column/spandrel plate, after fracture of the top chord gusset plate.

Figure B-11
Shear failure of floor truss connections from column/spandrel plate.

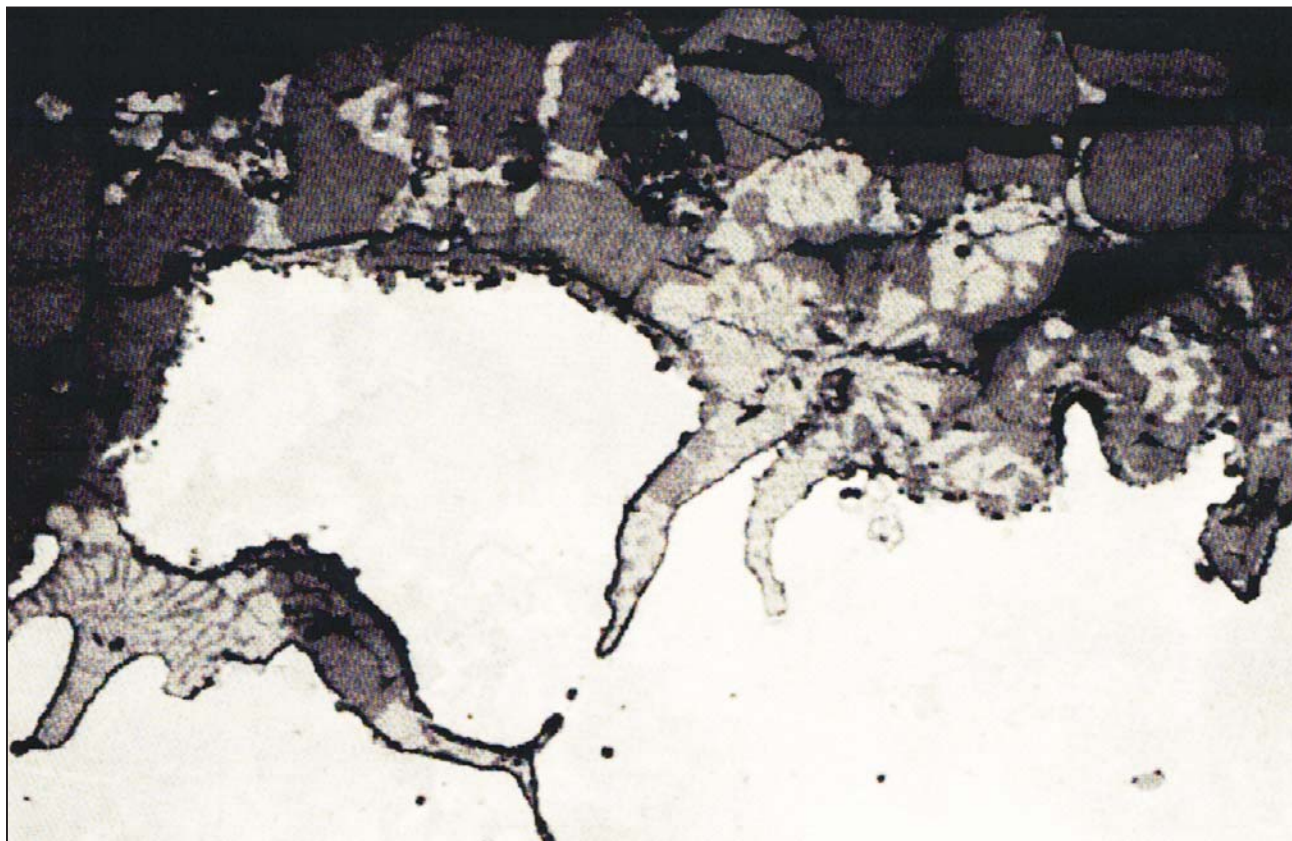
Figure C-7 Deep penetration of liquid into the steel. (Note: Hot corrosion of the steel can produce "islands" of steel surrounded by liquid, which will make erosion of the steel much easier.)

section of the steel that is unaffected by the hot corrosion. Figure C-7 illustrates the deep penetration of the liquid into the steel's structure. In order to identify the chemical composition of the eutectic, a qualitative chemical evaluation was done using energy dispersive X-ray analysis (EDX) of the eutectic reaction products. Figure C-8 illustrates the results of this analysis.

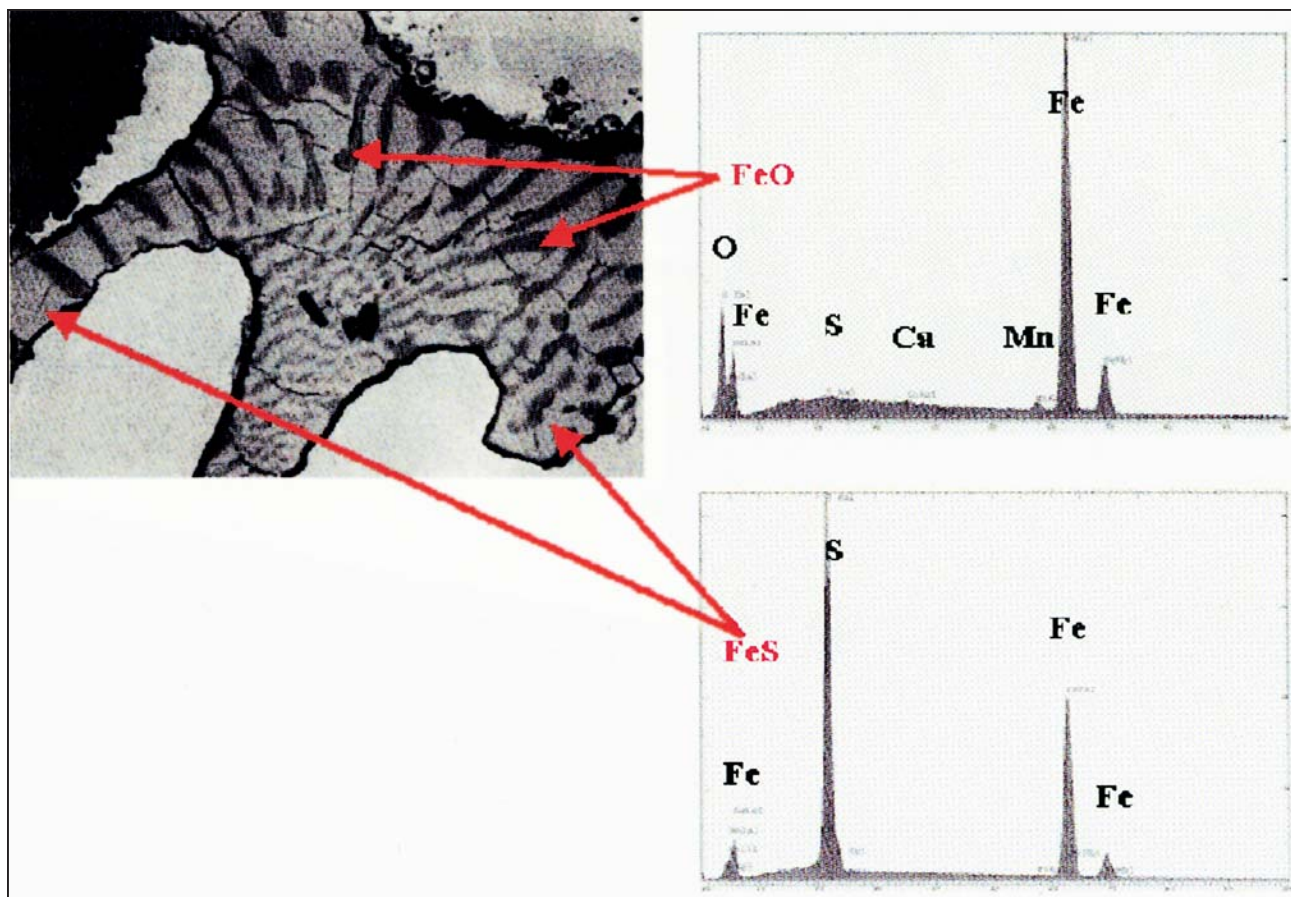
Figure C-8 Qualitative chemical analysis.

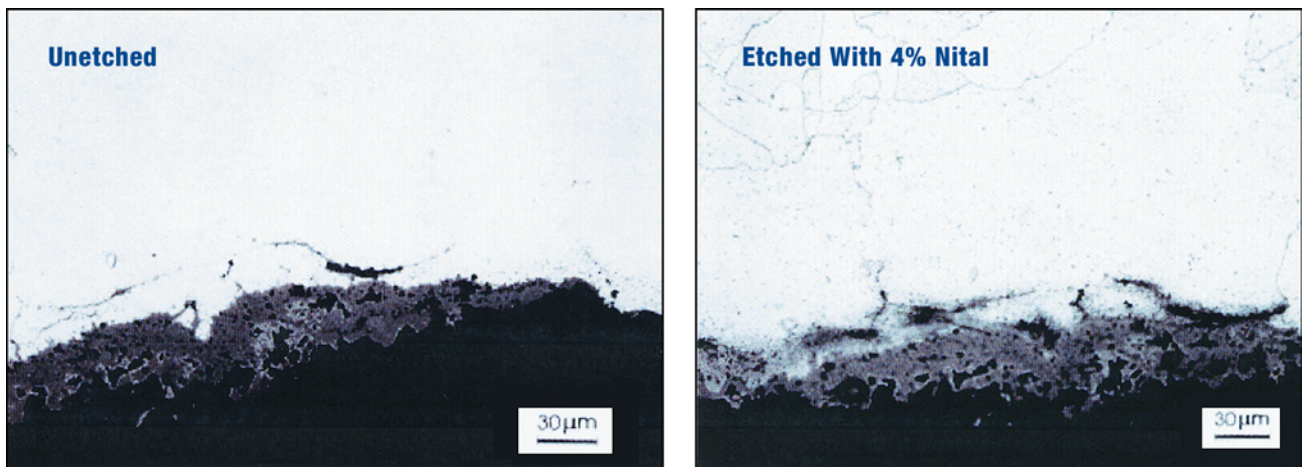
Figure C-10 Grain boundary corrosion attack.

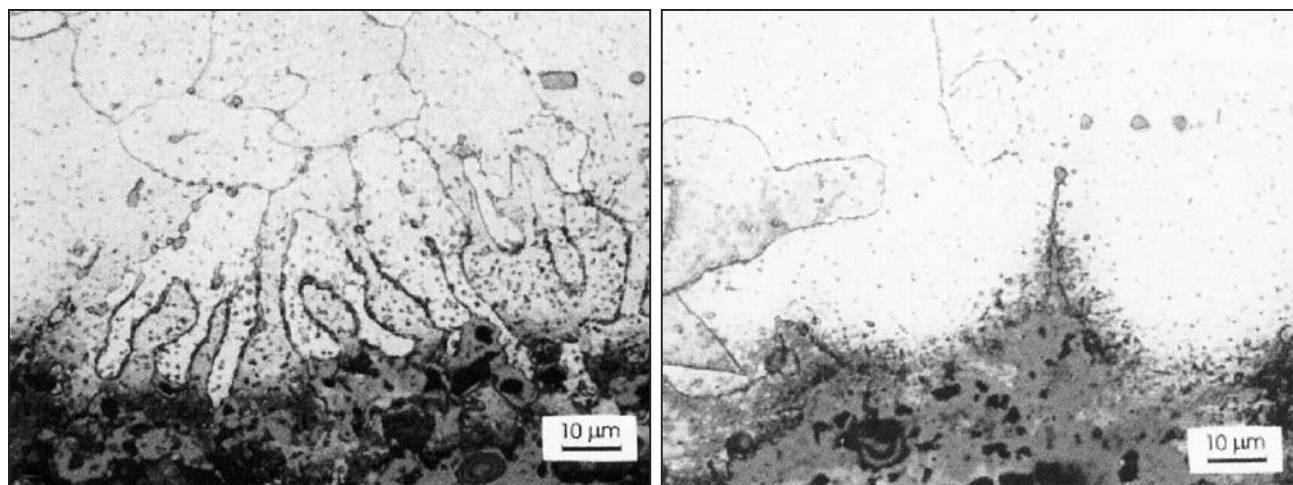
Figure C-13 shows the region where a qualitative chemical analysis of the eroded region was performed. The comparison of the EDX spectra from the specific regions identified in Figure C-13 shows concentration of copper and sulfur in the grain boundaries in addition to iron sulfide formation adjacent to iron oxide in the oxidized surface layer. Sulfide formation within the steel microstructure increases in concentration as the oxidized region is approached from the steel side. This is clearly shown in Figure C-14.

The larger sulfides further into the steel are the more stable manganese sulfides that were formed when the steel was made. The smaller sulfides that have formed as a result of the fire do not contain significant amounts of manganese, but rather are primarily sulfides containing iron and copper. These sulfides have a lower melting temperature range than manganese sulfide. It is much more difficult to tell if melting has occurred in the grain boundary regions in this steel as was observed in the A36 steel from WTC 7. It is possible and likely, however, that even if grain boundary melting did not occur, substantial penetration by a solid state diffusion mechanism would have occurred as evidenced by the high concentration of sulfides in the grain interiors near the oxide layer. Temperatures in this region of the steel were likely to be in the range of 700–800 °C (1,290–1,470 °F).

Figure C-14 Gradient of sulfides into the steel from the oxide-metal interface.

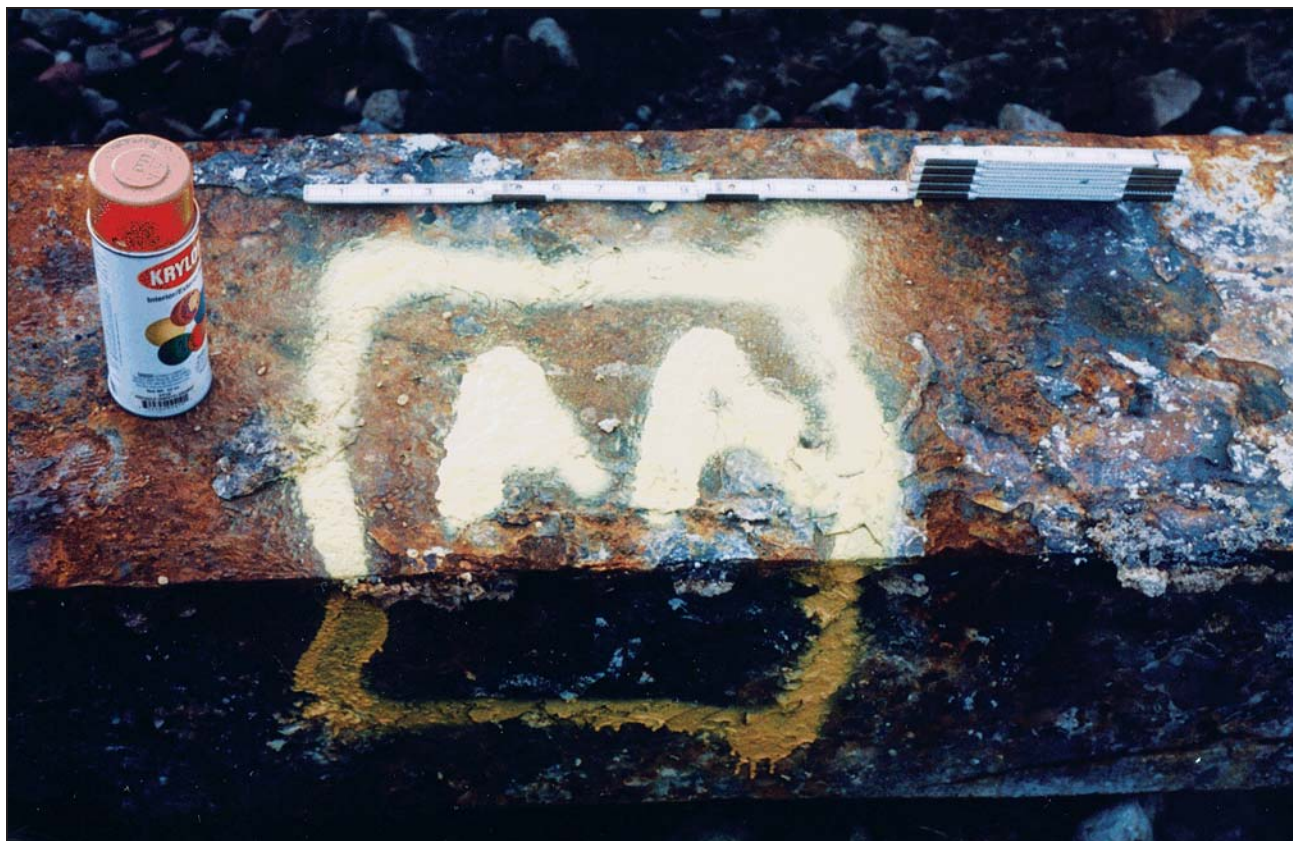
Figure D-11 Burnt steel piece marked for cutting of coupon.

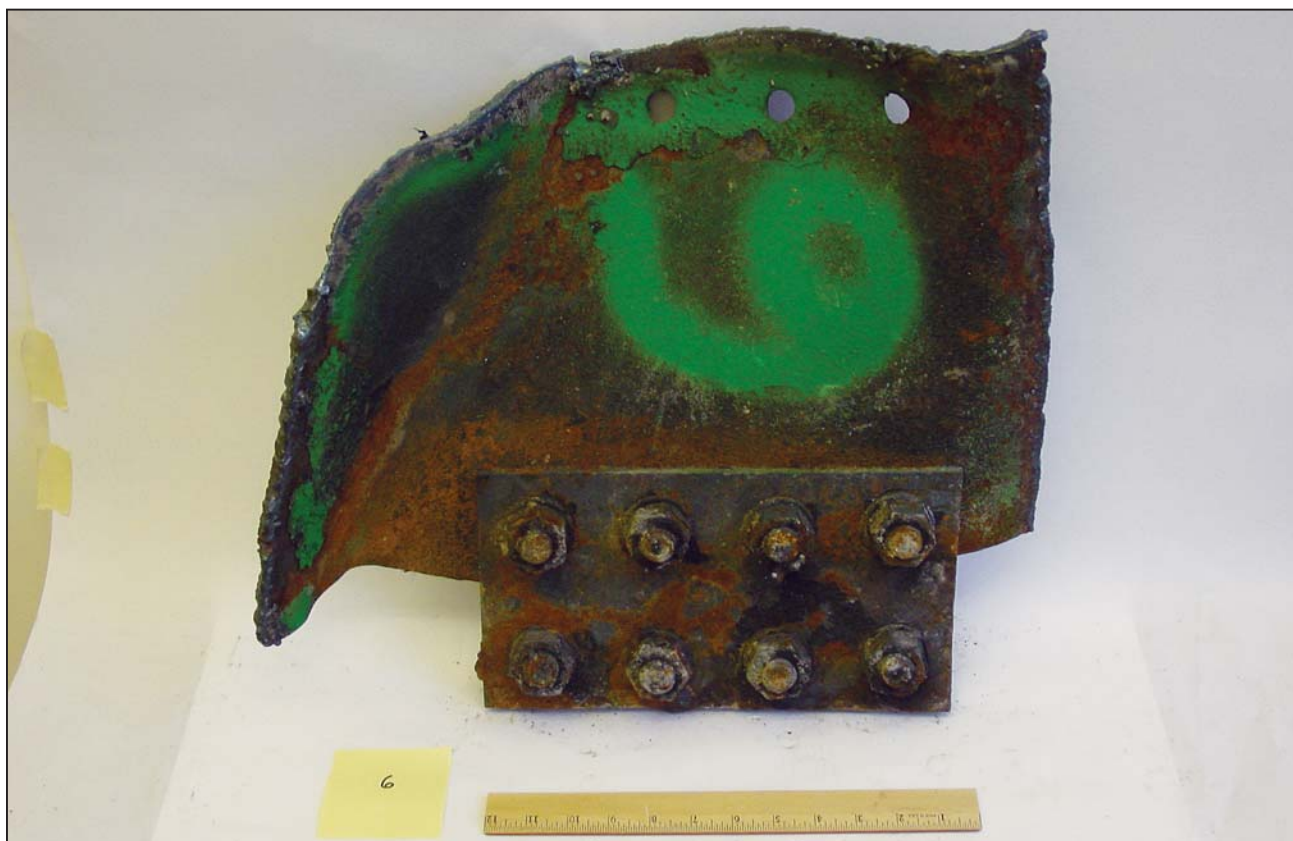
Figure D-12 Coupon cut from WTC 5 showing web tear-out at bolts.

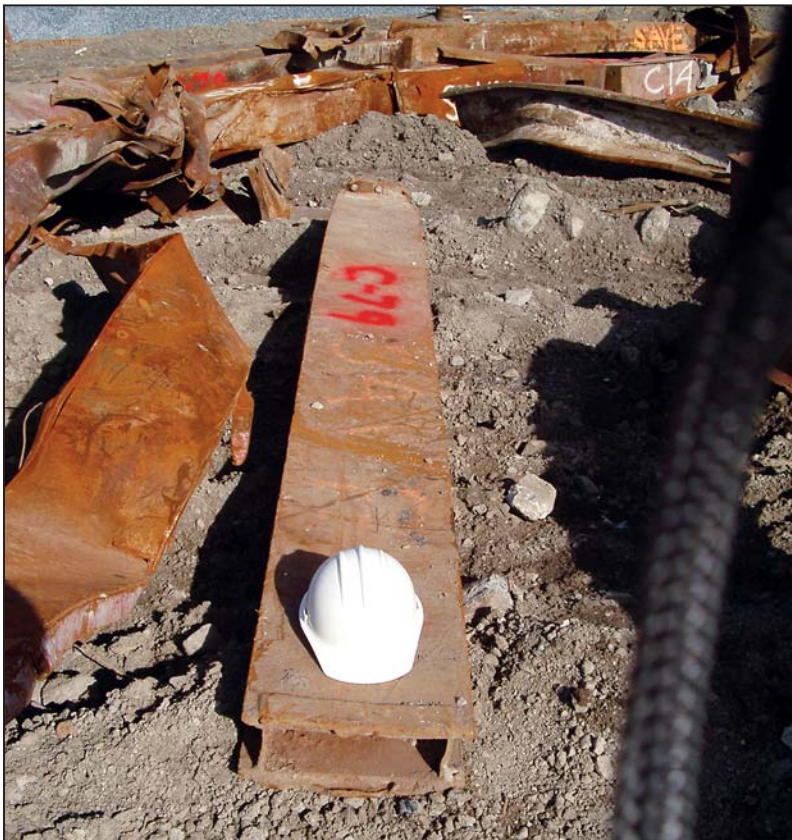
Figure D-13
WTC 1 or WTC 2 core column (C-74).

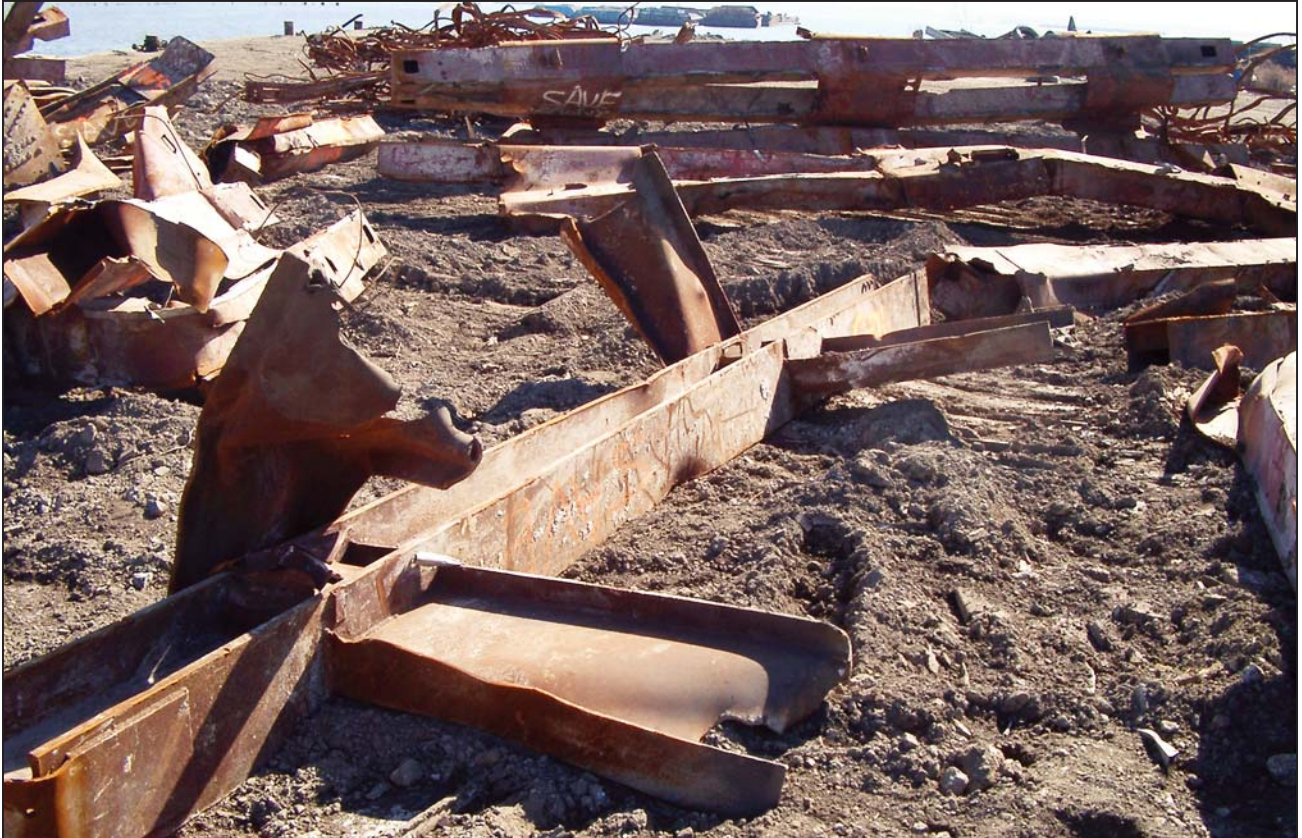
Figure D-14 WTC 7 W14 column tree with beams attached to two floors.

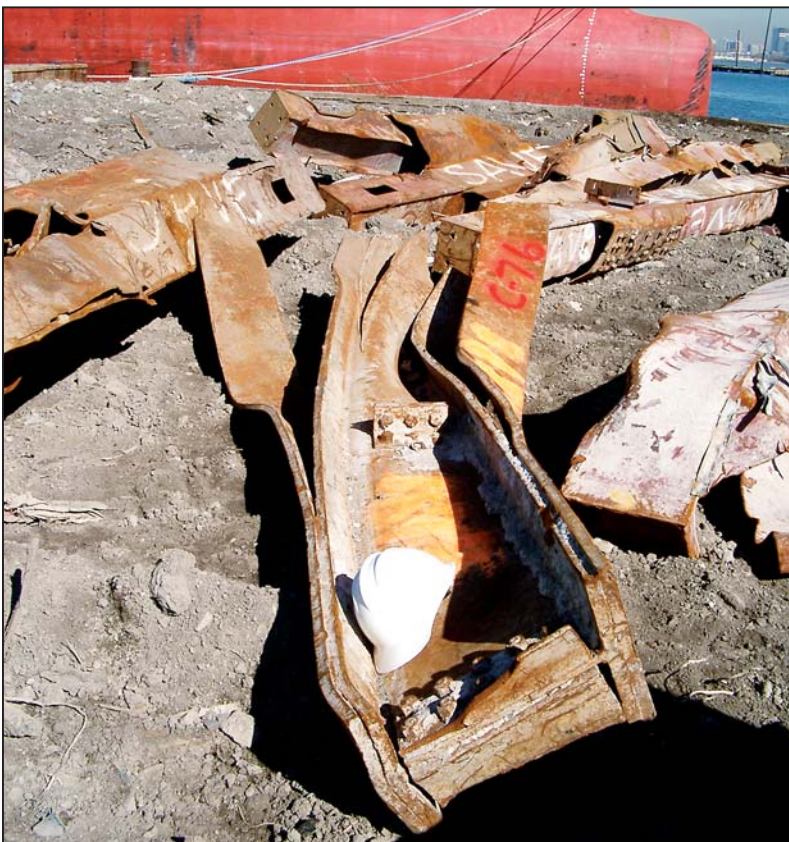
Figure D-15
Built-up member with failure along stitch
welding.

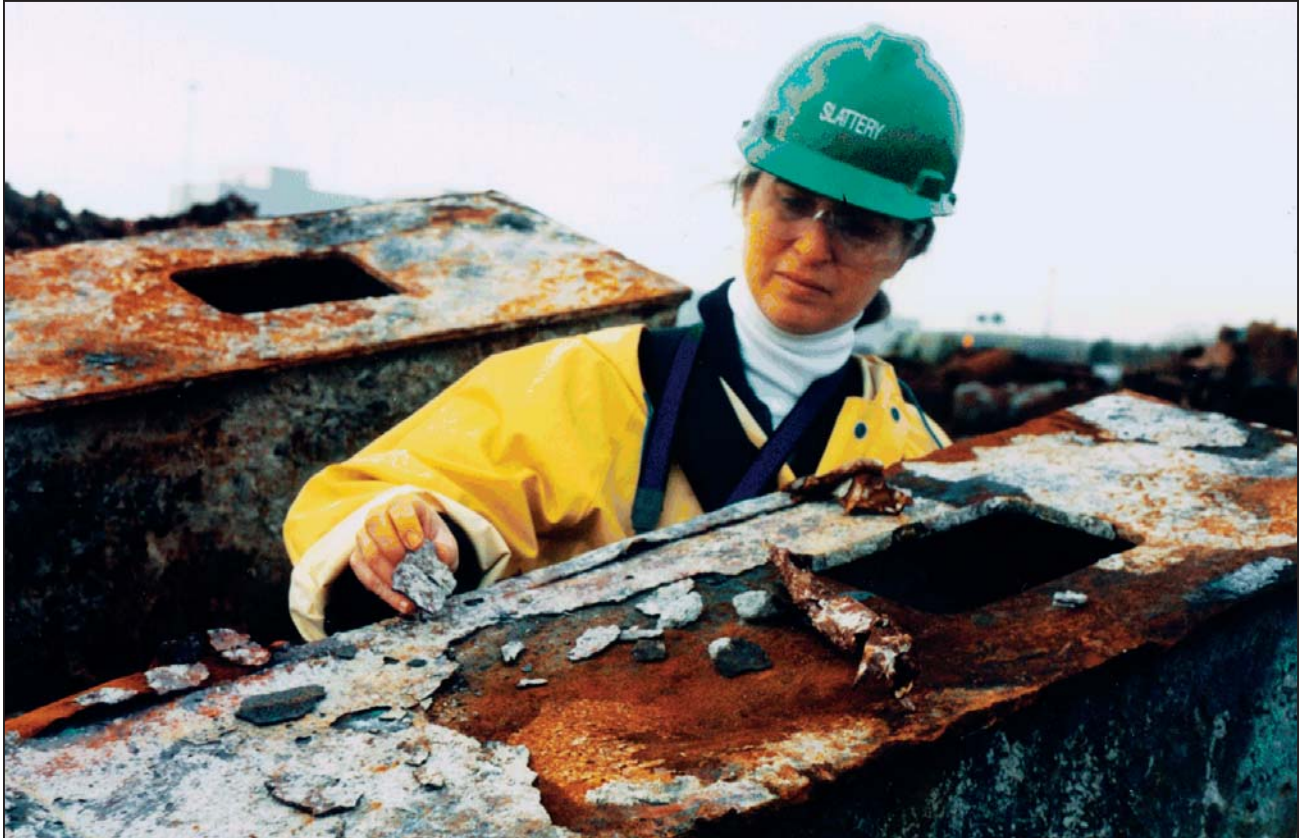
Figure D-16 Engineer inspecting fire damage of perimeter column tree from WTC 1 or WTC 2.

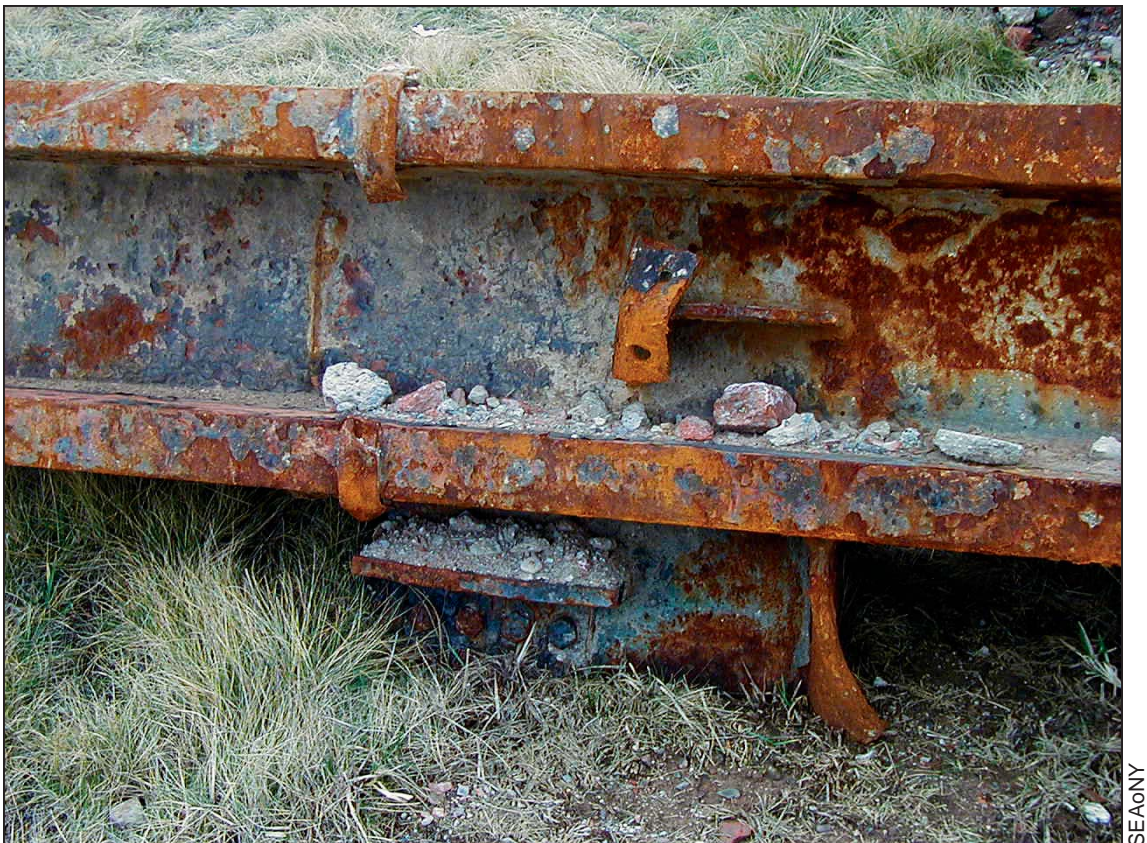
Figure D-17 Seat connection in fire-damaged W14 column from WTC 7.

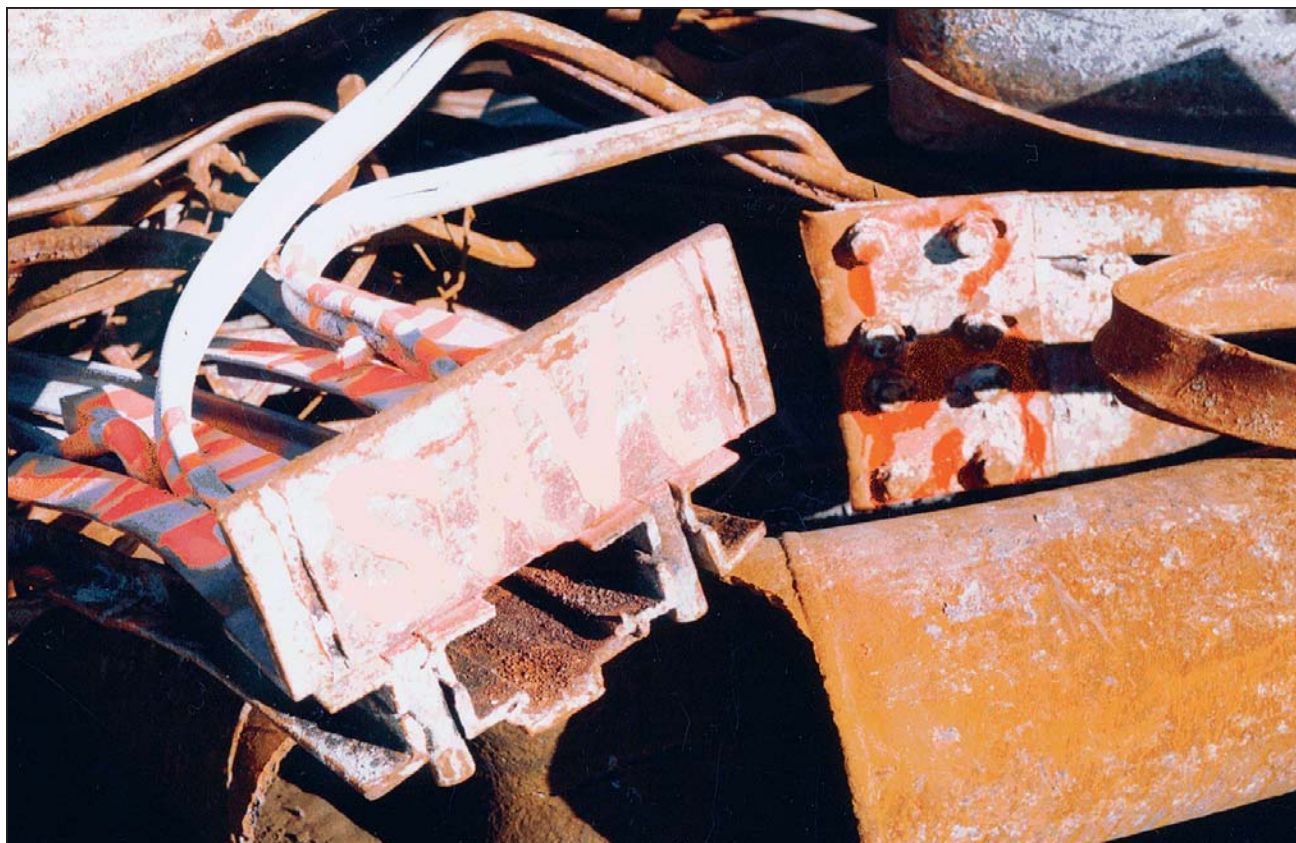
Figure D-18 WTC 1 or WTC 2 floor-truss section with seat connection fractured along welds.

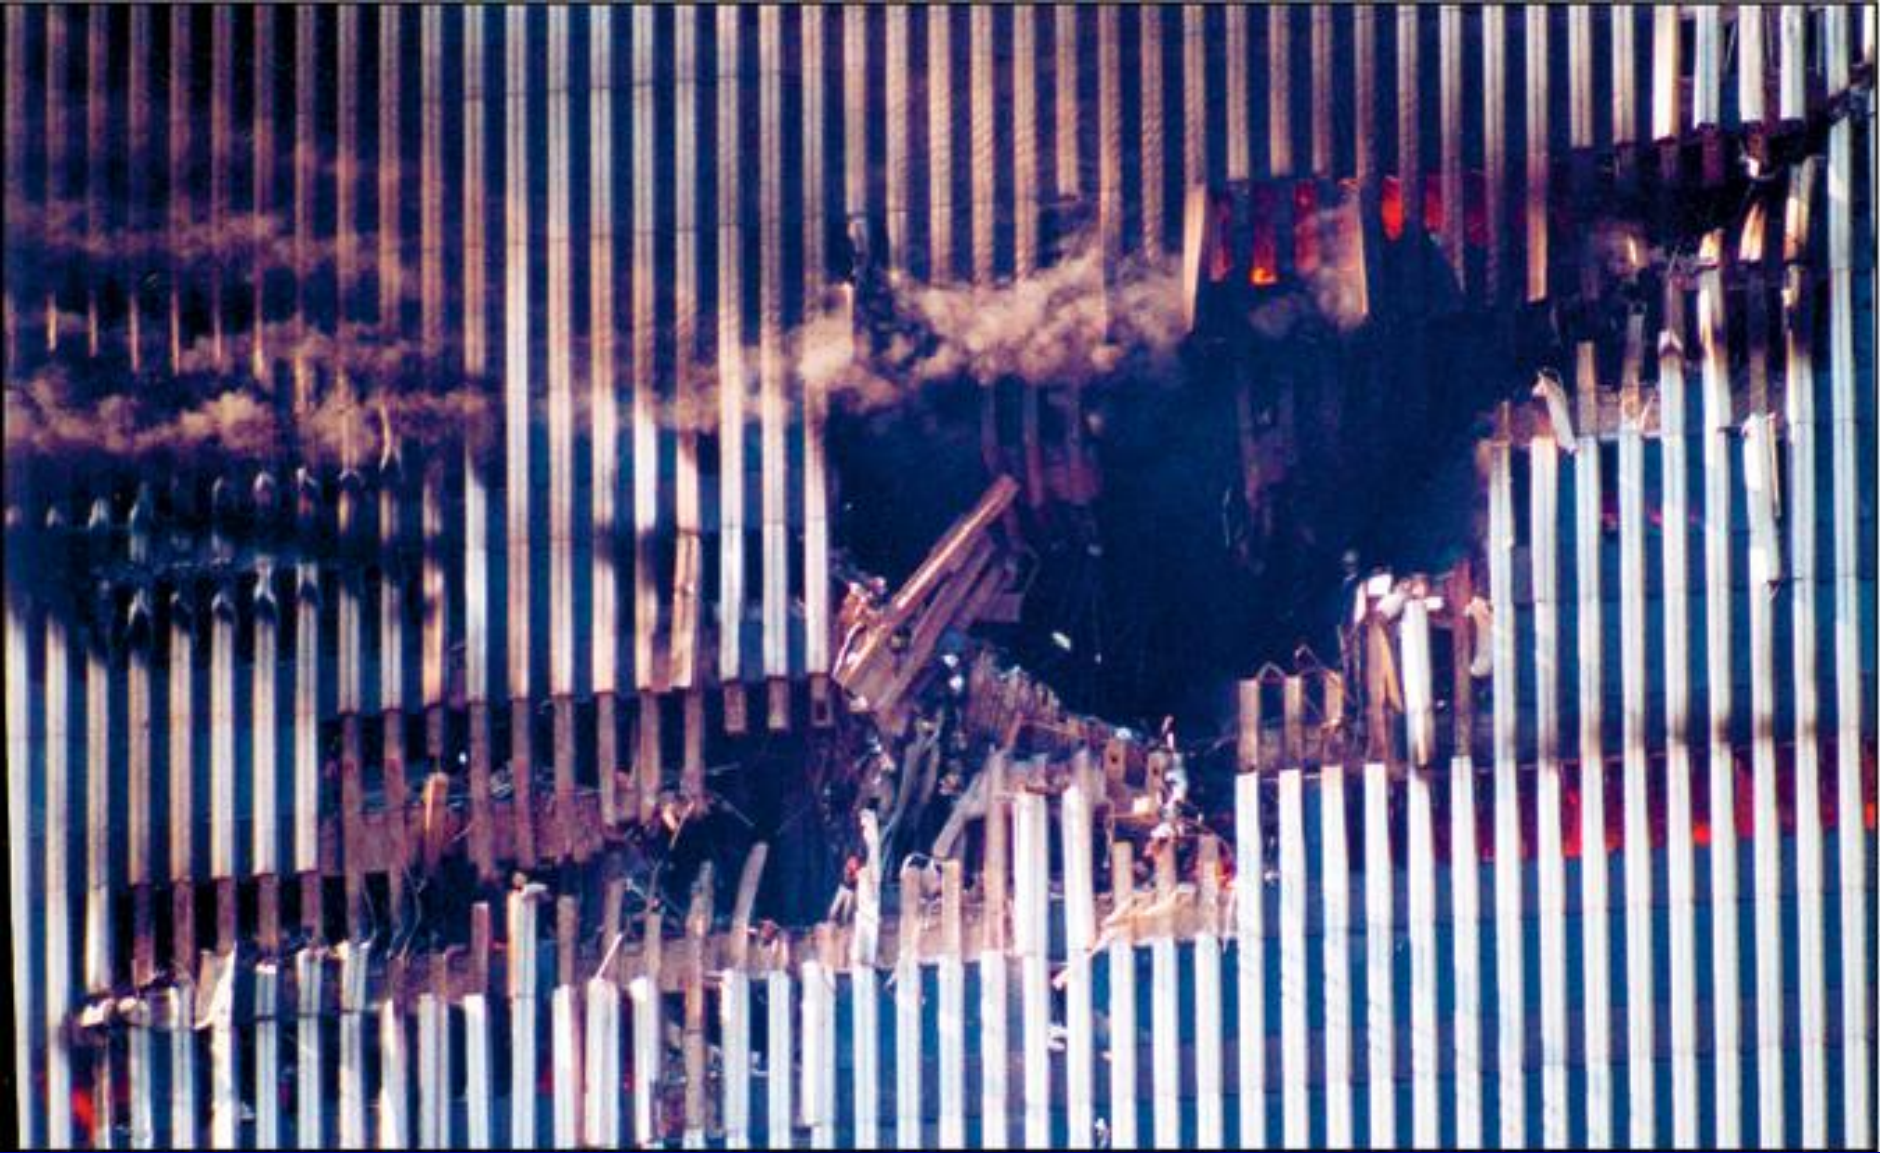
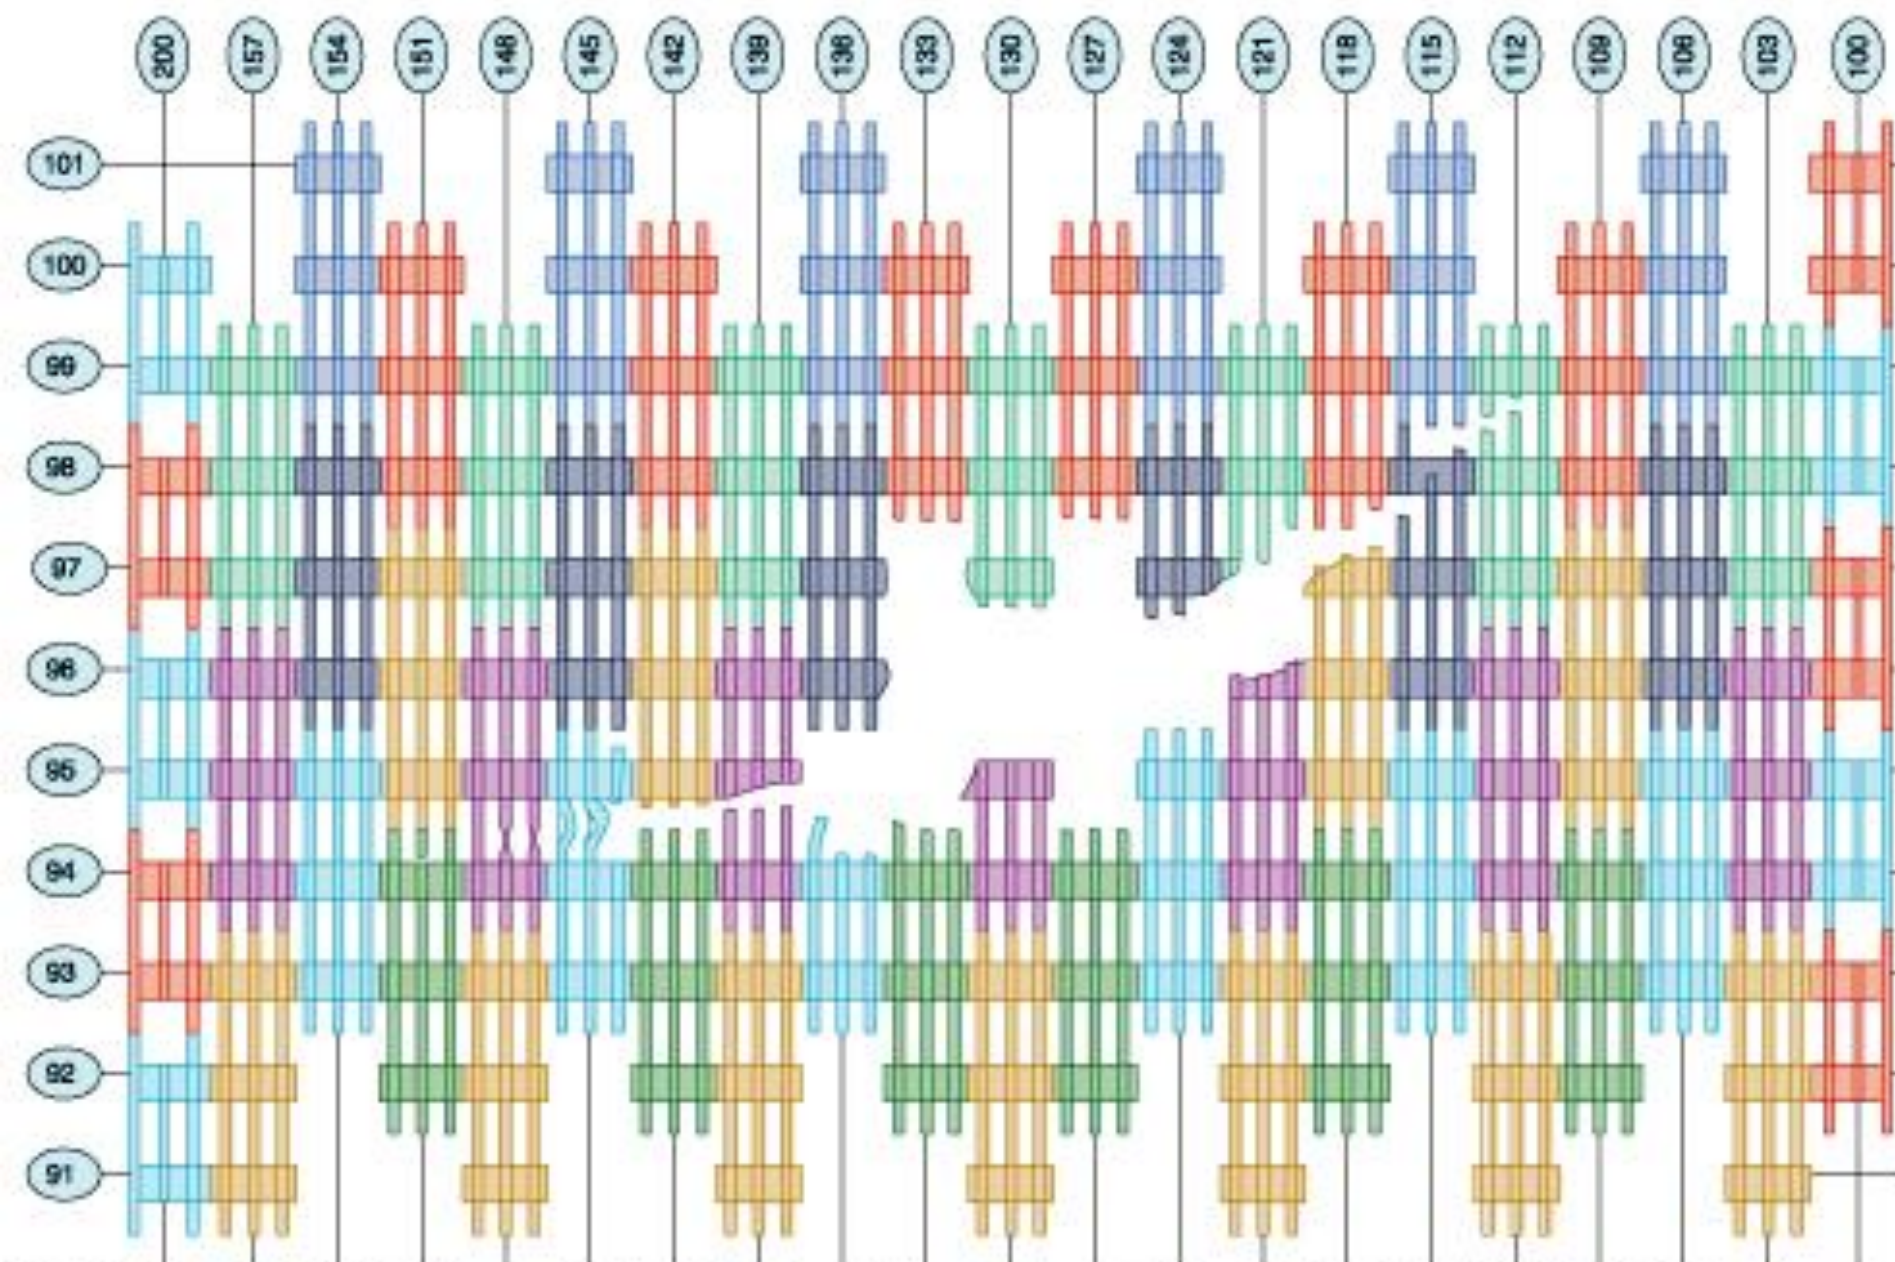
(2) Damage to column lines 111-115 at level 98 is estimated.

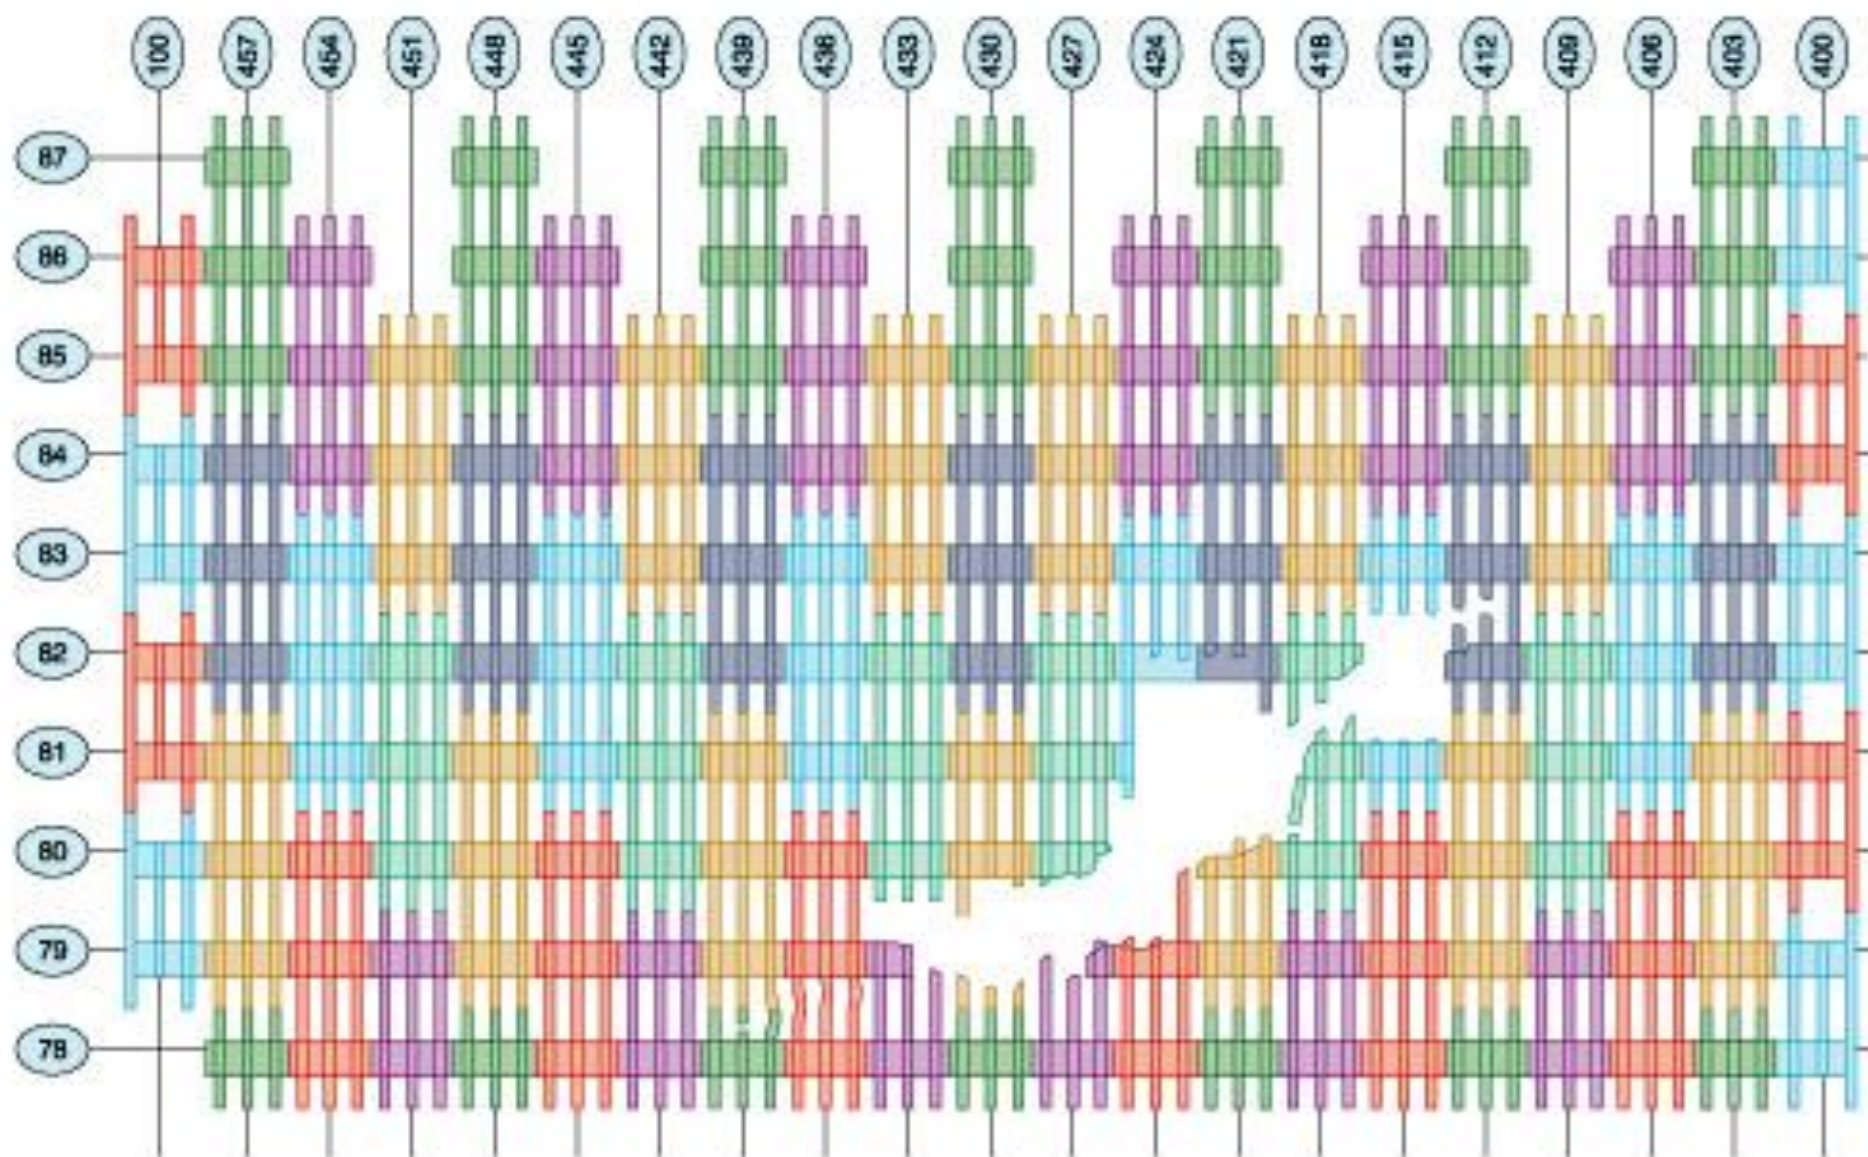
- (1) Column damage captured from photographs and enhanced videos.
- (2) Damage to column lines 413-418 at levels 81 and 82 is estimated.
- (3) There is not sufficient information to detail damage to column lines 408-411 at levels 83-84.
